### INTRODUCTION

Sear Brown performed a site review and survey of the Capitol grounds to determine the condition of site features such as sidewalks, stairways, curb and gutters, handicap ramps, parking lots, and utilities. These items were photographed and logged and are included in the Exterior Site Survey found in the Appendices. Sear Brown then analyzed the capacities and conditions of the existing utilities to determine whether or not they complied with current standards and met the operational needs of the facilities they serviced. Recommendations were made for improvements to the site features and utility systems for the Capitol site.

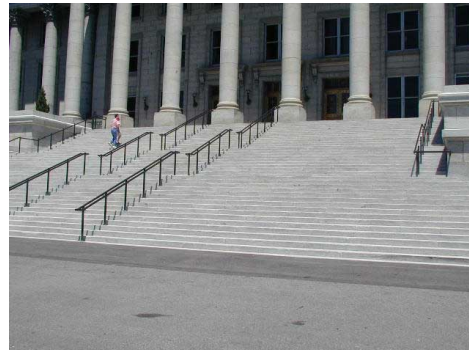
The stairway features at the west entrance to the Capitol are in poor condition as shown in the photos below. The stairway features on the south side of the Capitol are also showing signs of deterioration. The concrete steps and surrounding ledges are spalling and deteriorating. The top of the ledge has also chipped away. The stairs to the Mormon Battalion are in poor condition and in need of repair. The stairs are covered with loose concrete chips and rocks, creating a safety hazard for visitors.

*SOUTH ENTRANCE STAIRS TO THE CAPITOL*
